# Proprietary Patching Material Trial Viafix (All Materials Comparison)

**24 Month Report**

Document Title/No: 24 Month, All Materials Comparison Report

Client Reference: 09 Via 01  
(Viatec UK Ltd)

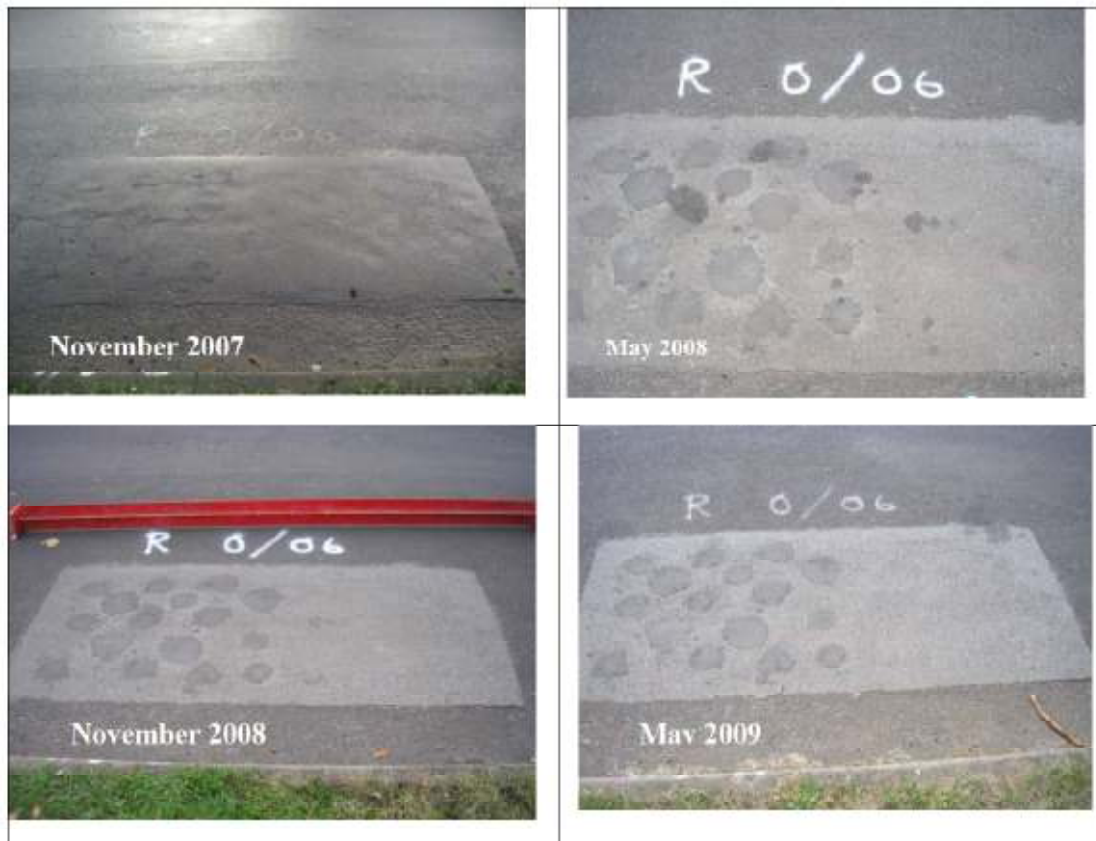
- No visual change to texture
- Aggregate exposed

- No obvious visual deformation after installation (see note)

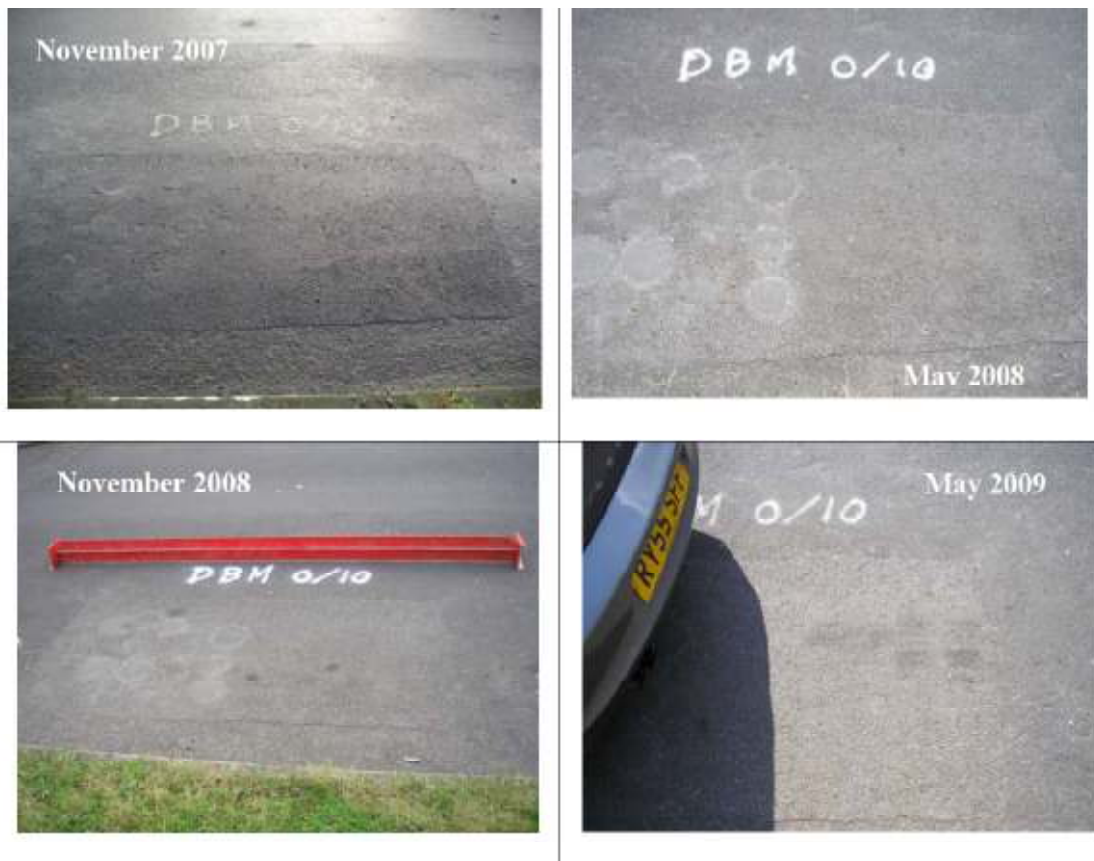
May 2009, Unable to move parked car but full test/inspection carried out.

- No visual change to texture
- Aggregate becoming exposed

- No visual deformation

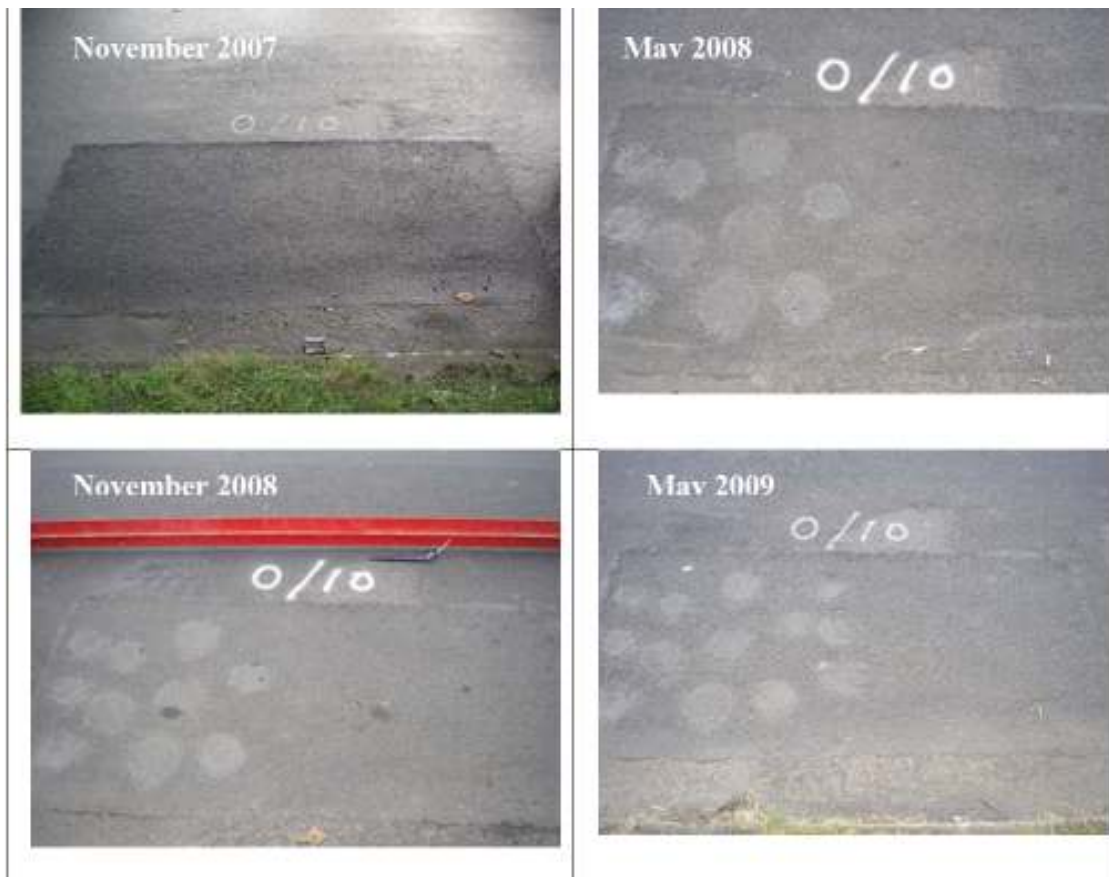
- No visual change to texture
- Aggregate gradually becoming more exposed

- No obvious visual deformation

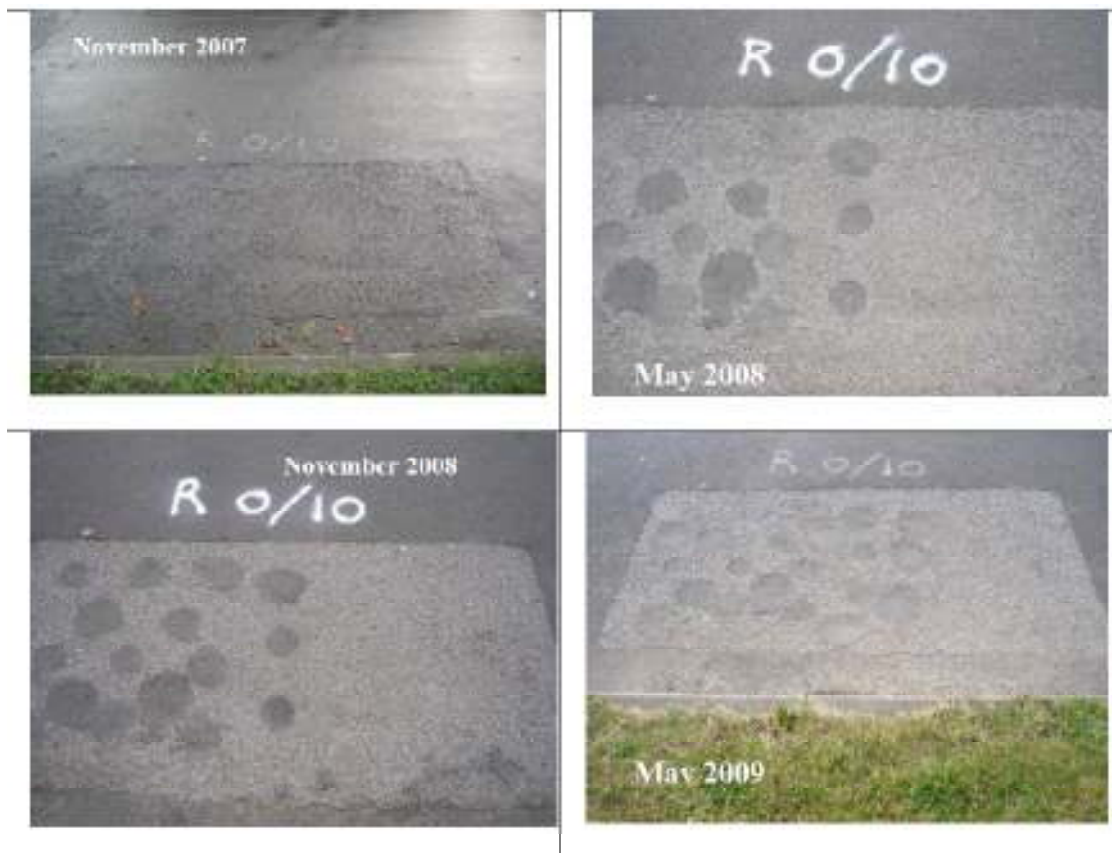
No visual change to the texture  
Aggregate exposed

No visual deformation

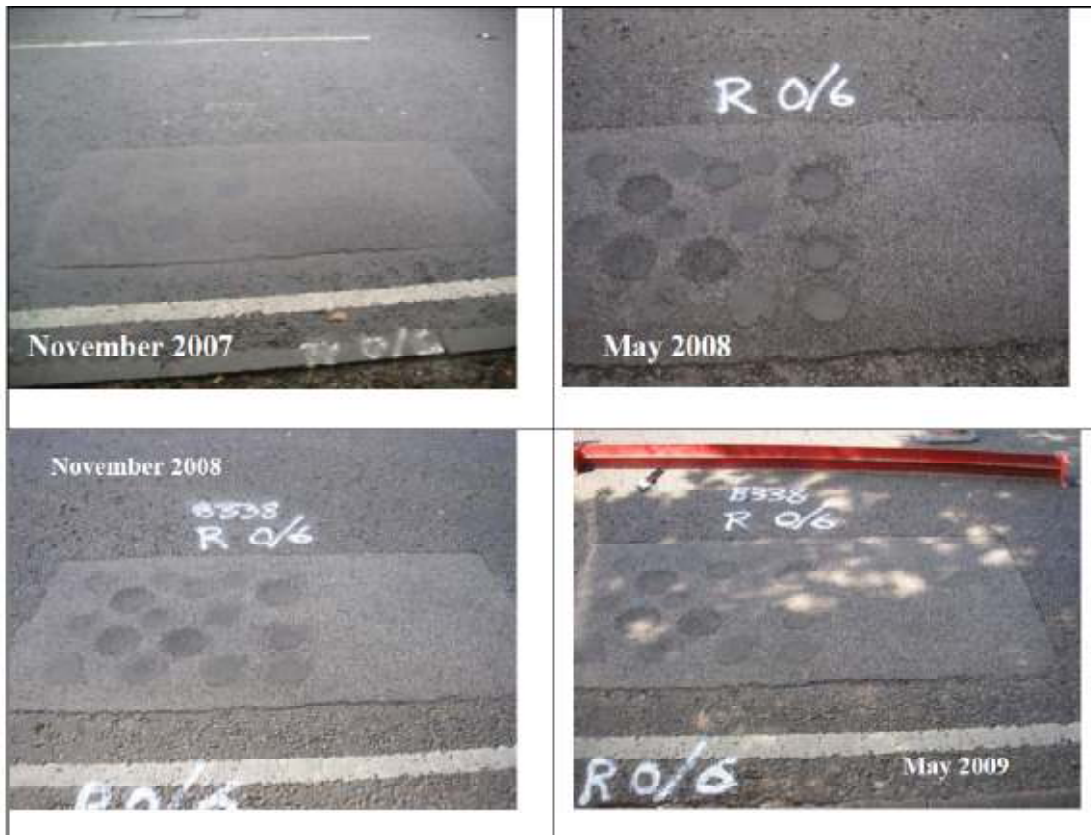
The surface texture appears to have slightly opened up under trafficking  
Aggregate exposed

No visual deformation

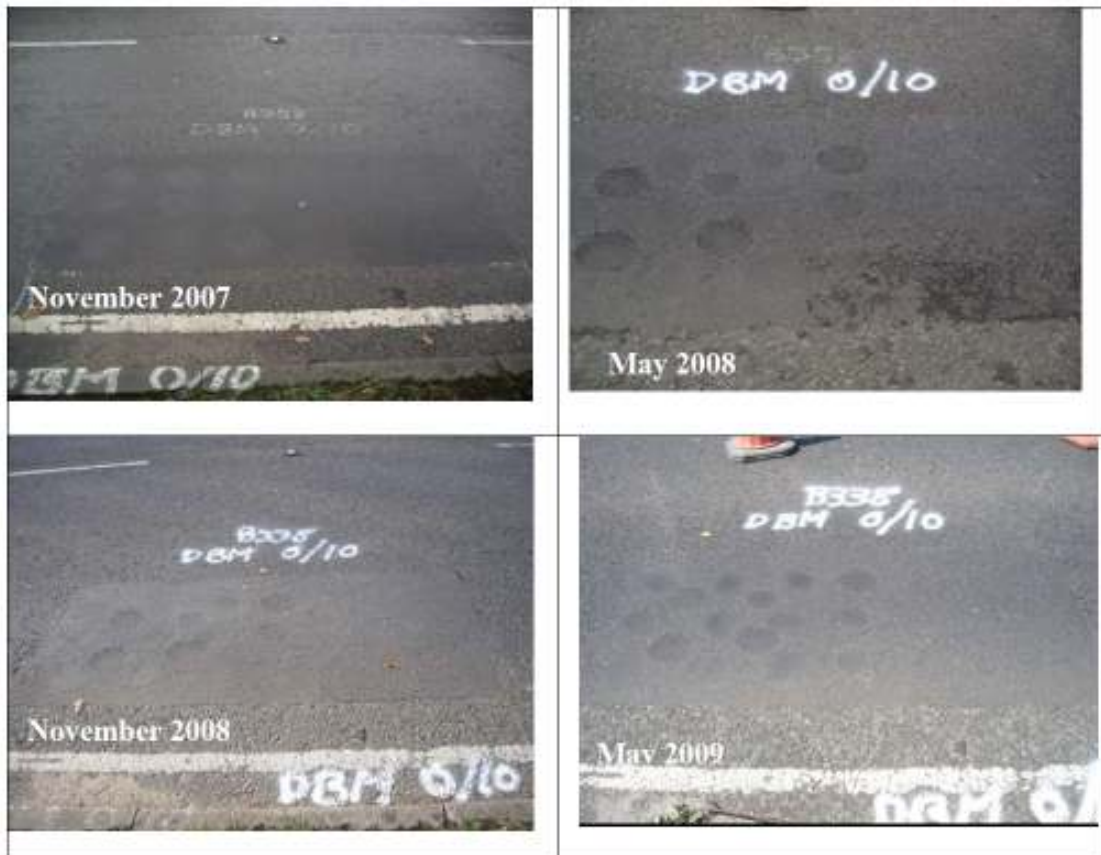
- No visual change to texture
- Aggregate exposed

- No visual deformation

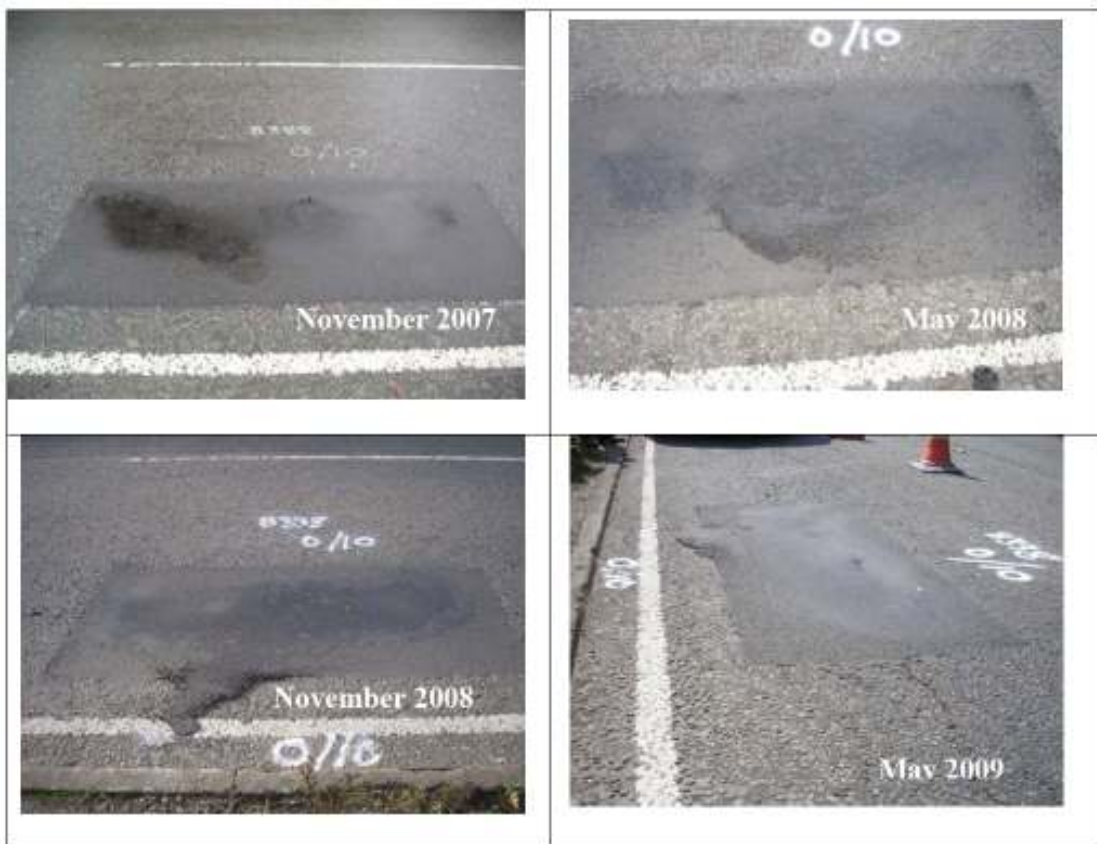
Serious "fattening up" resulting in loss of texture  
Excess binder flooding on surface

Serious deformation with material flowing out of the low side of the patch

This materials performance was surprisingly poor. Only on the least trafficked site did the material retain its integrity. With the higher traffic volumes the material on the two other sites very quickly fattened up and deformed to such an extent that it could have become a danger and require replacement before the end of the trial. Fortunately the patches just retained enough material not to reach the replacement criteria. Throughout the duration of the trial several attempts were made to core the material, it was not possible to extract any core suitable for testing.

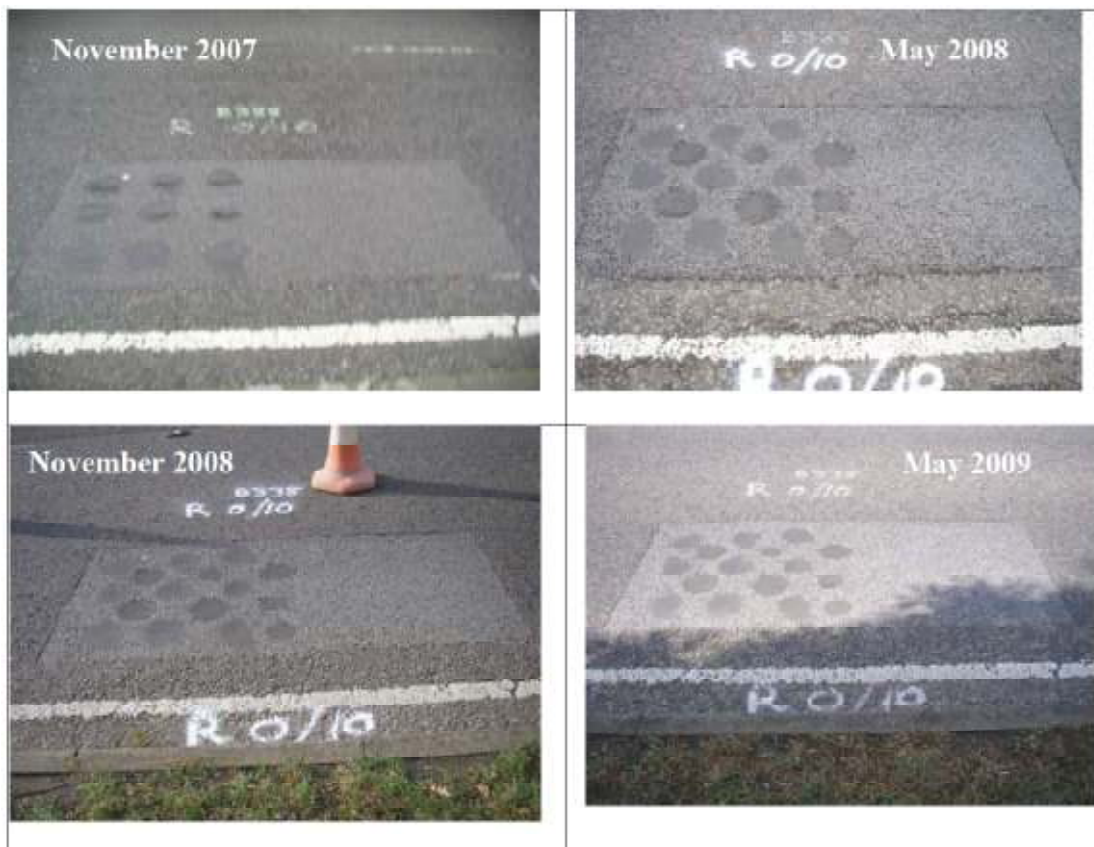
No visual change to texture  
Aggregate exposed

No visual deformation.

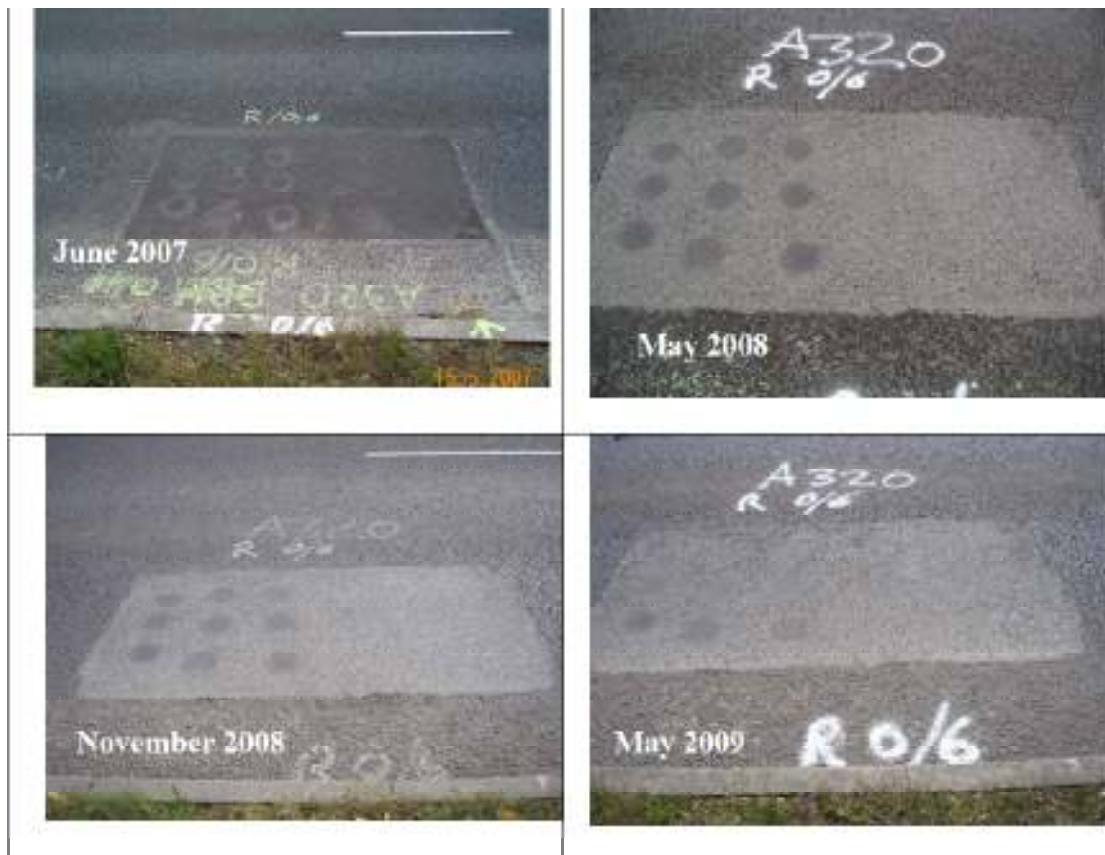
The surface texture appears to have slightly opened up under trafficking  
Aggregate exposed

No visual deformation

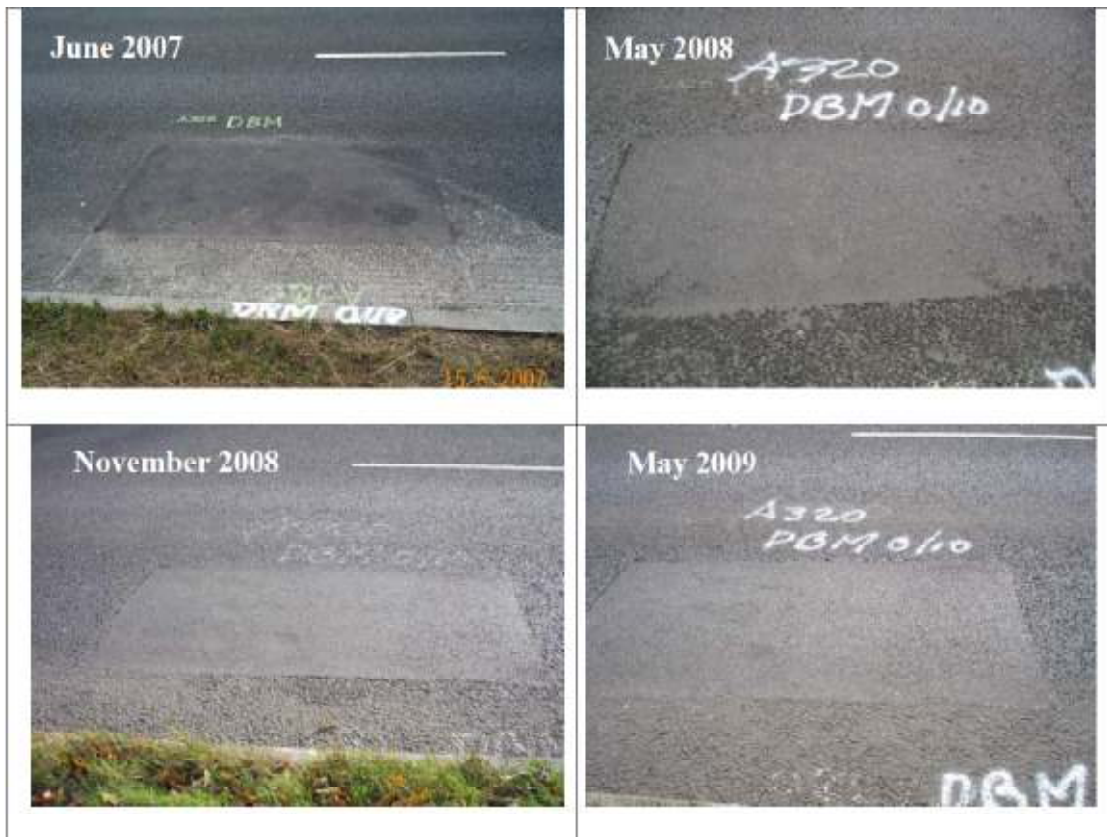
Little visual change, maybe just a slight opening of texture  
Aggregate exposed

No visual deformation

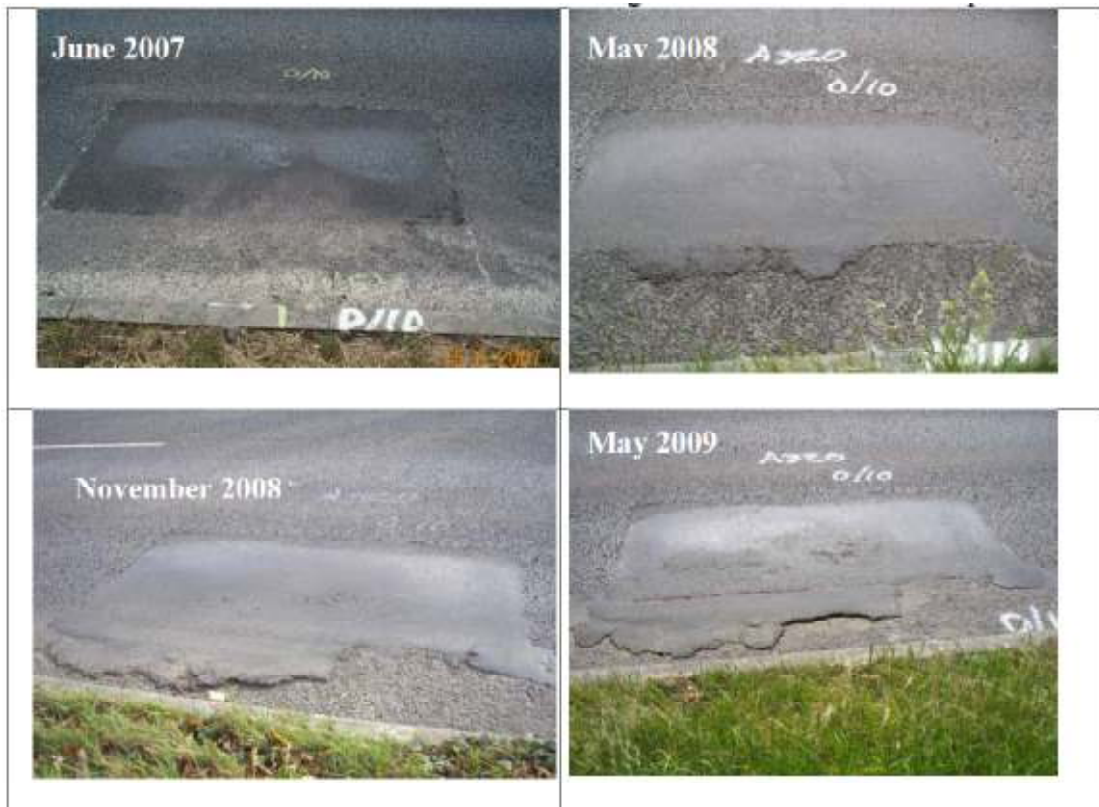
Serious "fattening up" resulting in loss of texture  
Excess binder flooding on surface

Serious deformation with material flowing out of the low side of the patch

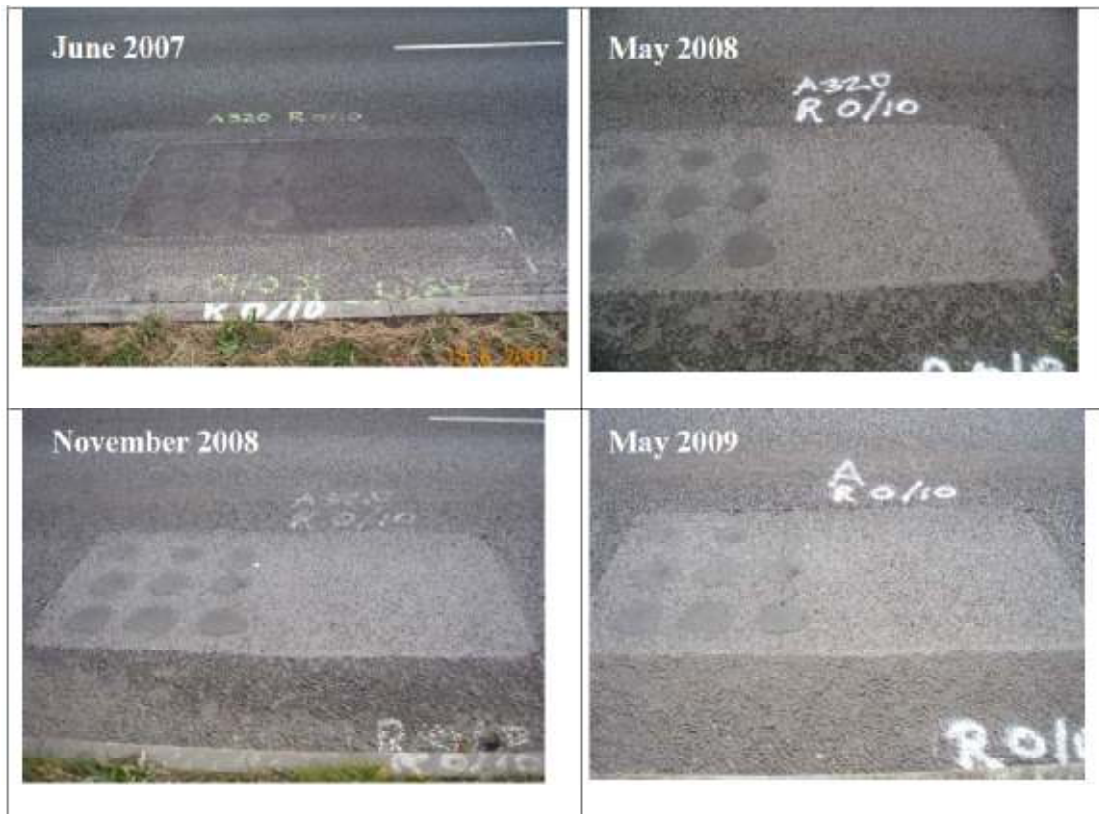
The surface texture appears to have slightly opened up under trafficking  
Aggregate exposed

No visual deformation

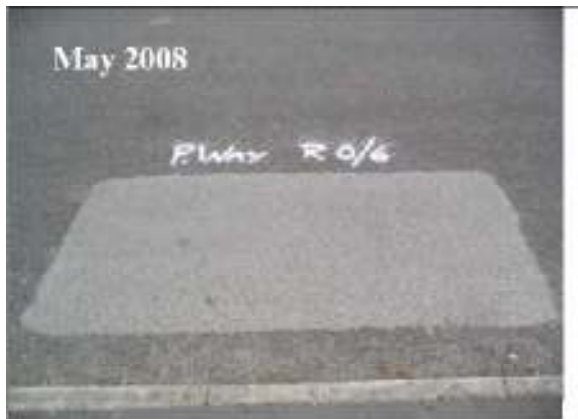
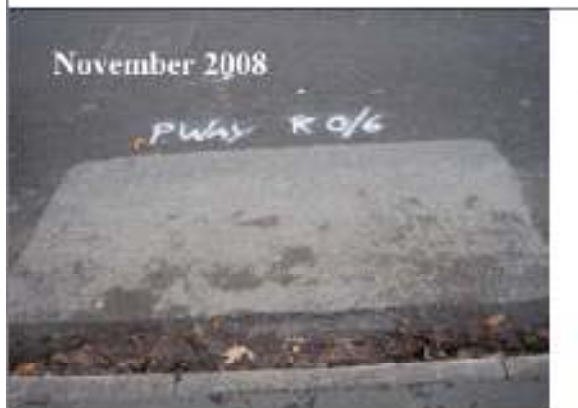
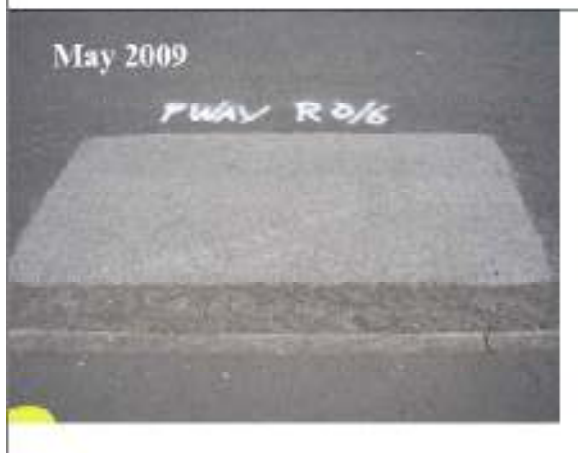
No visual change to texture

Aggregate exposed

No visual deformation

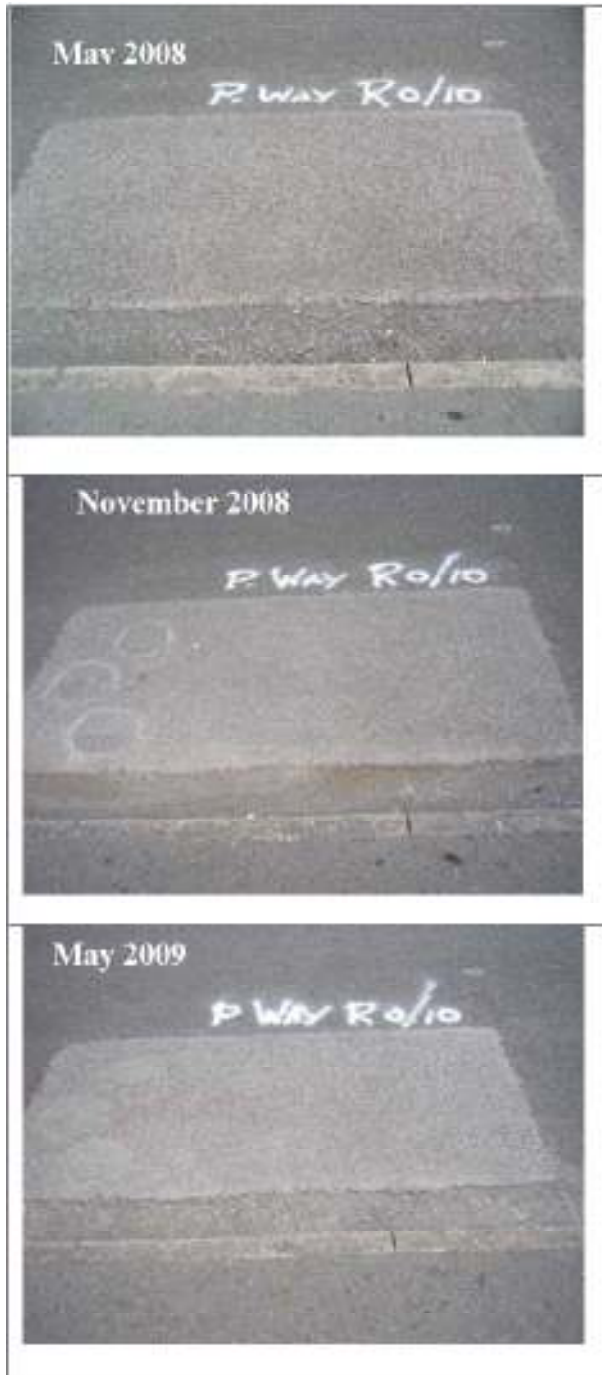
No visual change to texture  
Aggregate exposed

No visual deformation

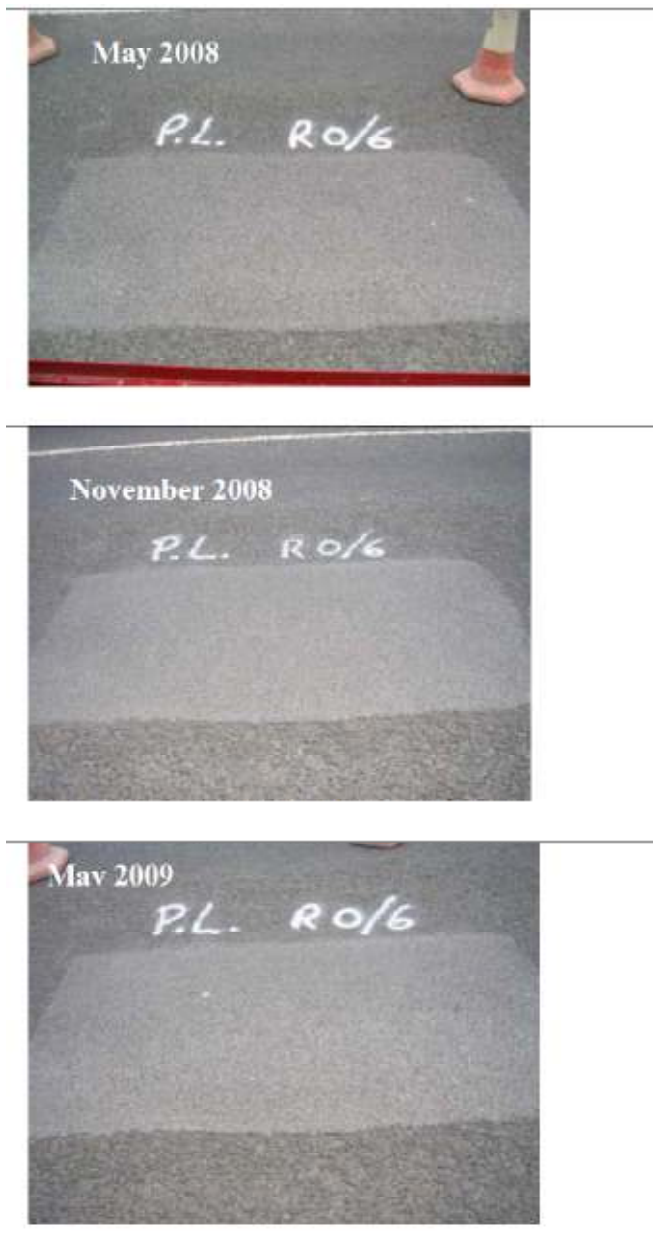
The surface texture appears to have slightly opened up under trafficking  
Aggregate exposed

No visual deformation

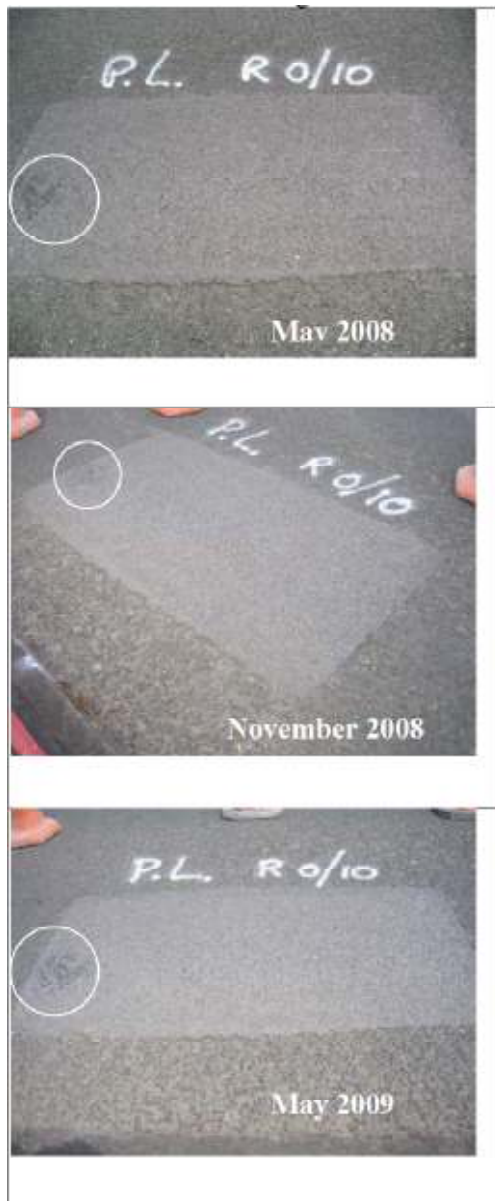
The surface texture appears to have slightly opened up under trafficking  
The texture appears consistent over the patch other than in a small area, which appears to have “fatted up” very slightly. (See circled area in photographs)  
Aggregate exposed

No visual deformation. The 3m straight edge indicated a degree of “hog” or swelling, but visually no noticeable change

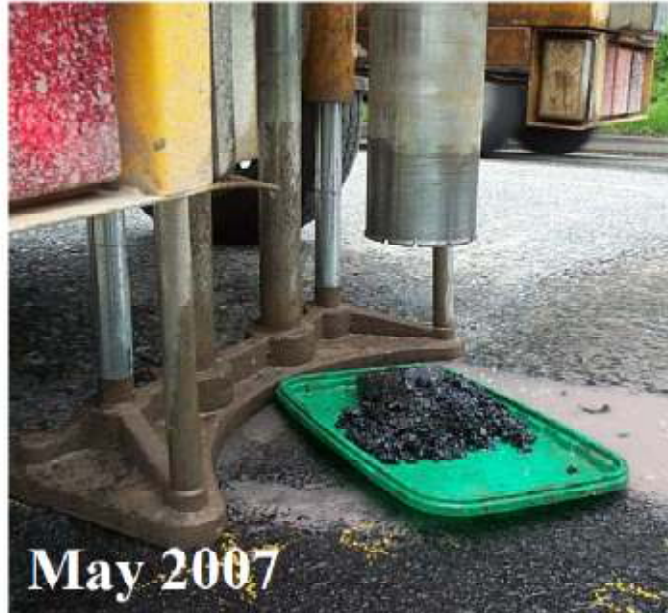
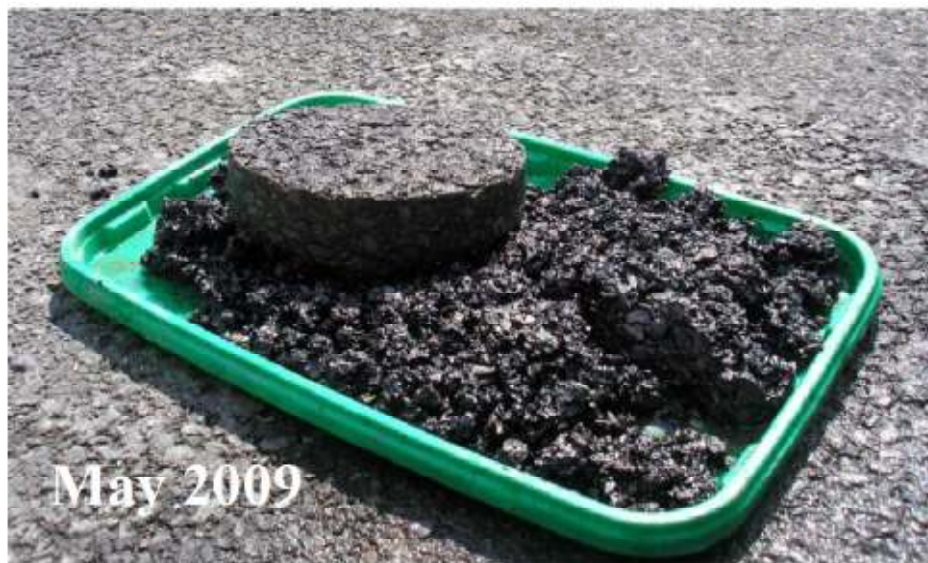
A programme of coring was carried out soon after installation of all the patches for wheel tracker and skid resistance testing. The coring team were unable to extract cores suitable for testing from the 0/10 BBA /HAPAS Approved PCSM. (see photographs below and laboratory test result).

During the conditioning pulses, the material failed to maintain the target deformation (7microns) and was exceeded in all cases.

The material was deemed to be too soft to test and further testing was aborted
